TRYON BARN
HISTORIC STRUCTURE REPORT
Conditions Assessment & Feasibility Study

MICHIGAN CITY, INDIANA
1402 Tryon Road

May 8, 2019

Tryon Farm Institute, Inc.

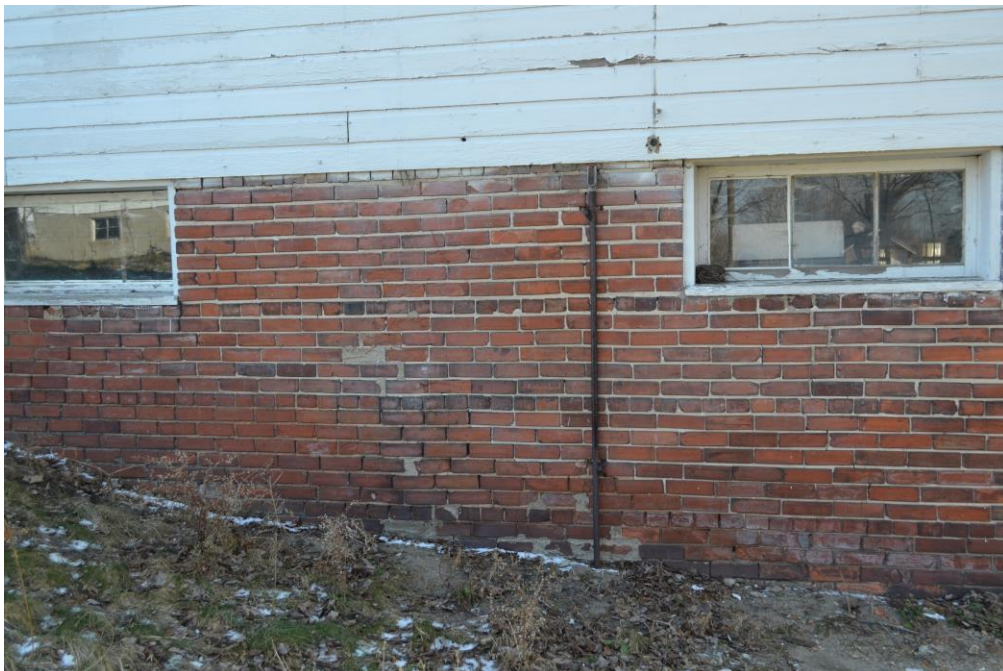
4. West basement wall demonstrates need for minor tuck-pointing near grade

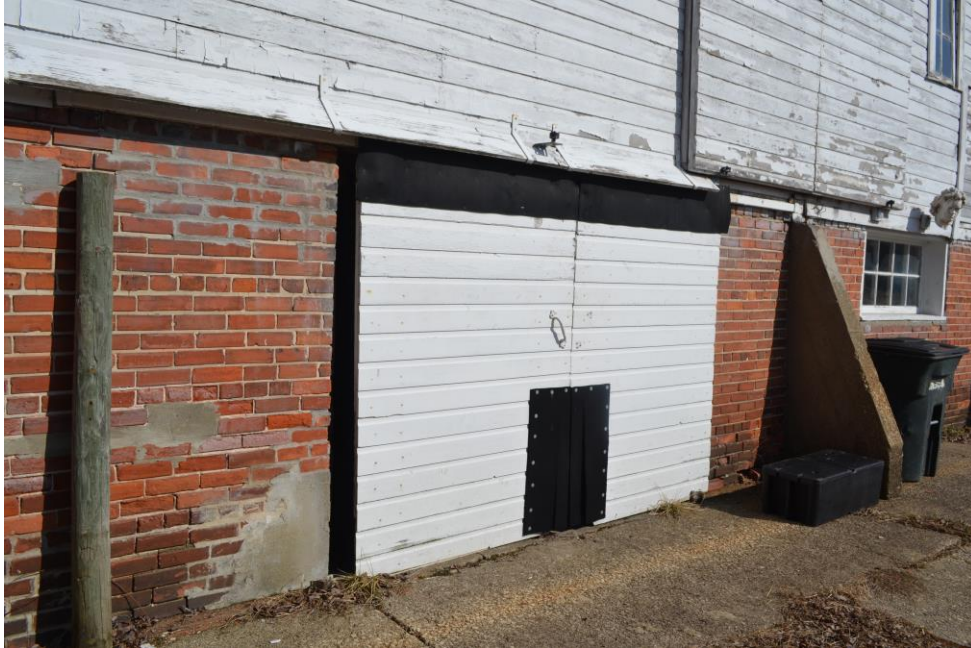
5. Inadequate masonry mortar repair that occurred in previous years should be addressed

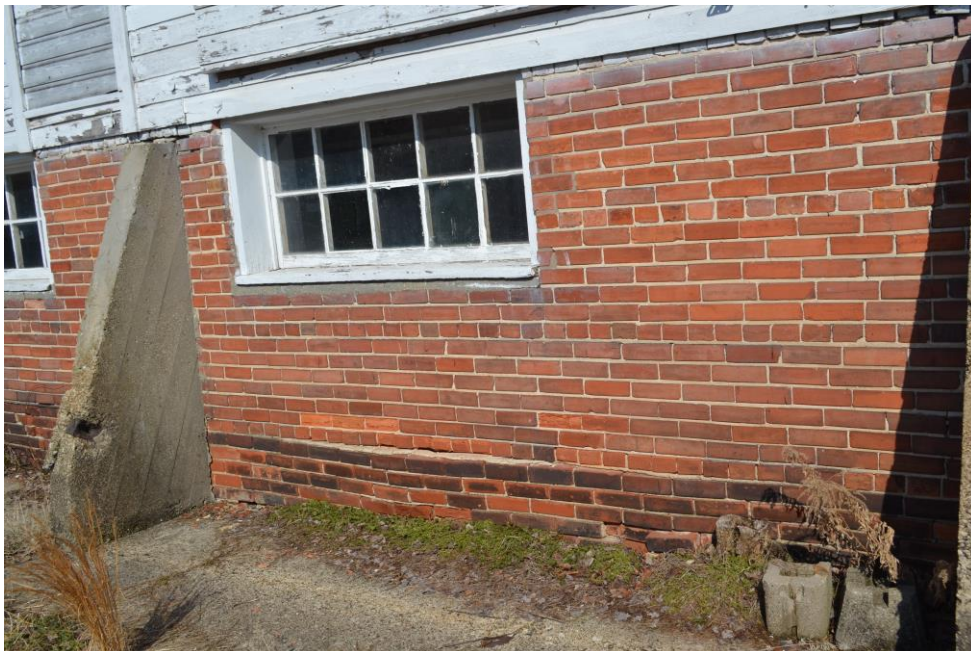
6. One of the most significant failures is a separation of face brick from the lower wall. It is unclear why the separation is occurring, but this can be removed and re-laid.

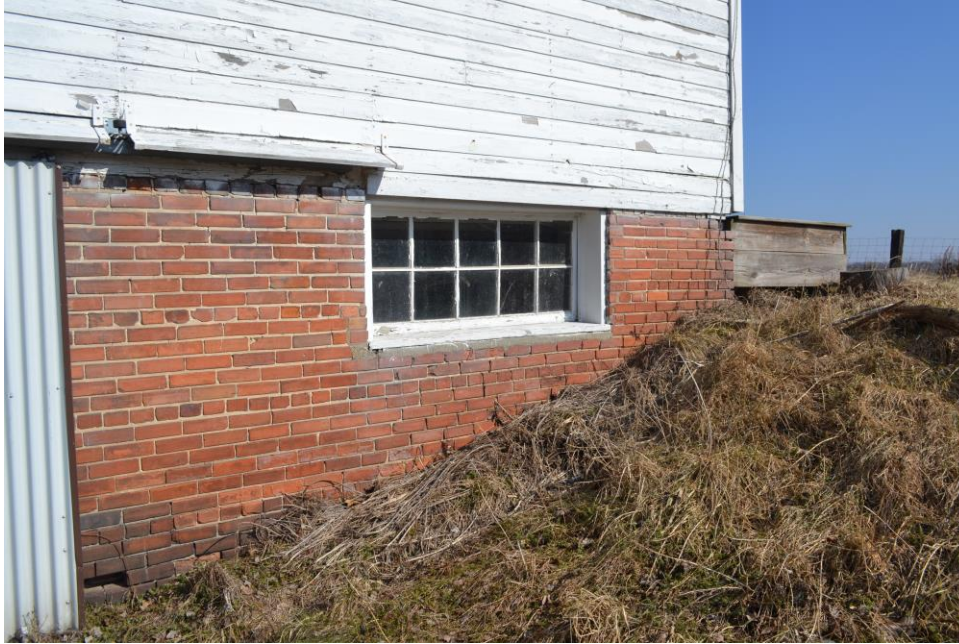
7. This best demonstrates the need for improved drainage and its lack creates need for masonry repair.

Recommended correction is excavation and membrane installation in areas where grade is banked up against the brick basement walls. Prior to membrane installation, mortar and brick repair may be required or full-scale masonry parging may prove most effective. Perimeter drainage with gravel backfill and perforated tile should be installed. Buried tiles with risers for future downspouts should also be installed at the same time. Because of available elevation fall to the south, the tiles can divert water around the building and to lower areas south of the barn. If desired, cisterns or barrels may be installed to aid in capturing rain for demonstration gardening/sustainable design. Install new, handicap accessible, concrete stoops/ramps to the north side of the building after drainage installation.

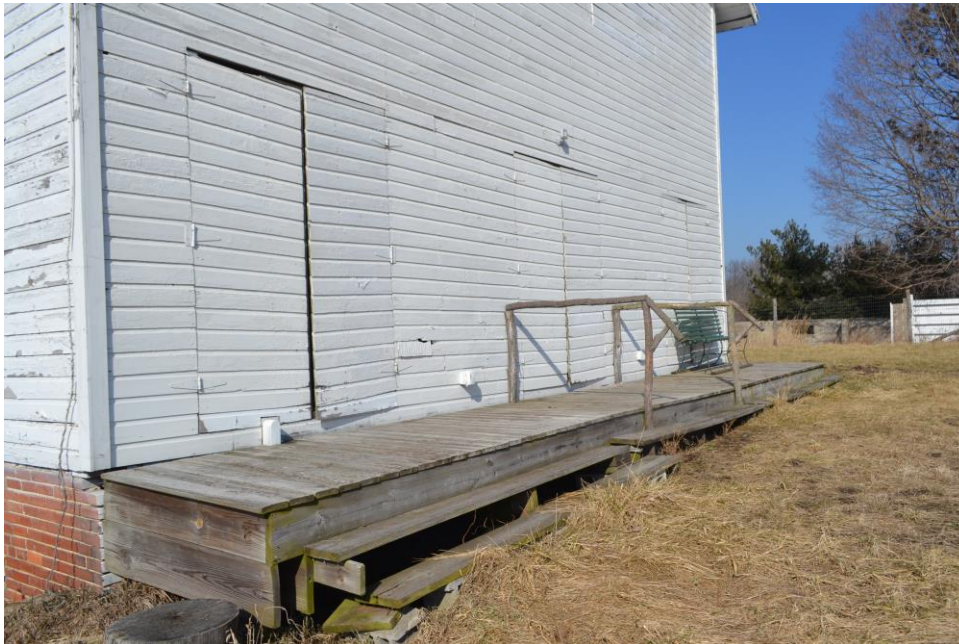
8. Recommended removal of deck for basement masonry wall repair.
A new deck may be installed after repair.

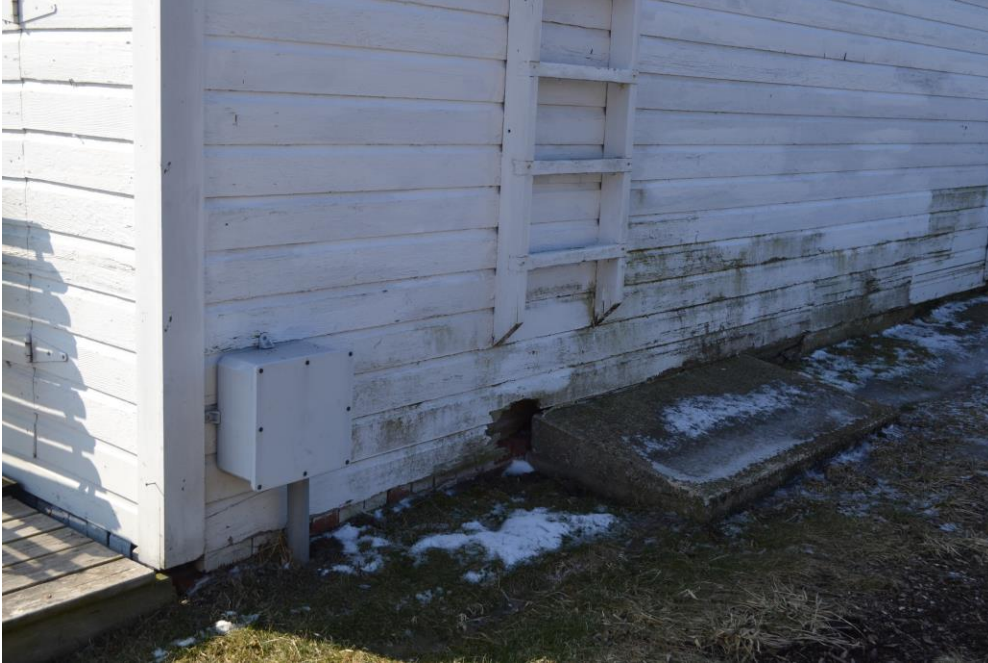
The lack of proper drainage away from the north wall is also creating a condition where wood rot in siding and structural members can occur due to splash conditions from stoops and swales and the inability of wood materials to dry (north-facing walls/algae recorded). No gutters or downspouts are fixed to the eaves, which may be an acceptable condition so long as water from the roof and grade is directed away from the building. As expected, these areas are most susceptible to paint failure and wood rot. Generally, however, the barn's wood siding and wood windows are in very good condition.

9. North wall suffers most from inadequate drainage because of water splash and lack of sun.

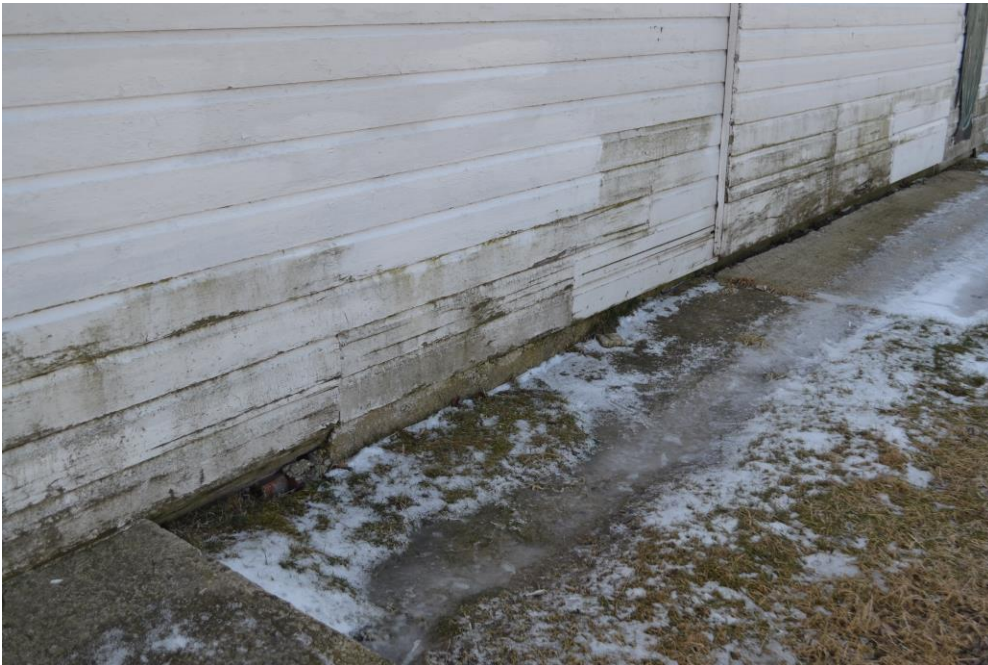
10. Algae and dampness leads to paint failure and wood rot.

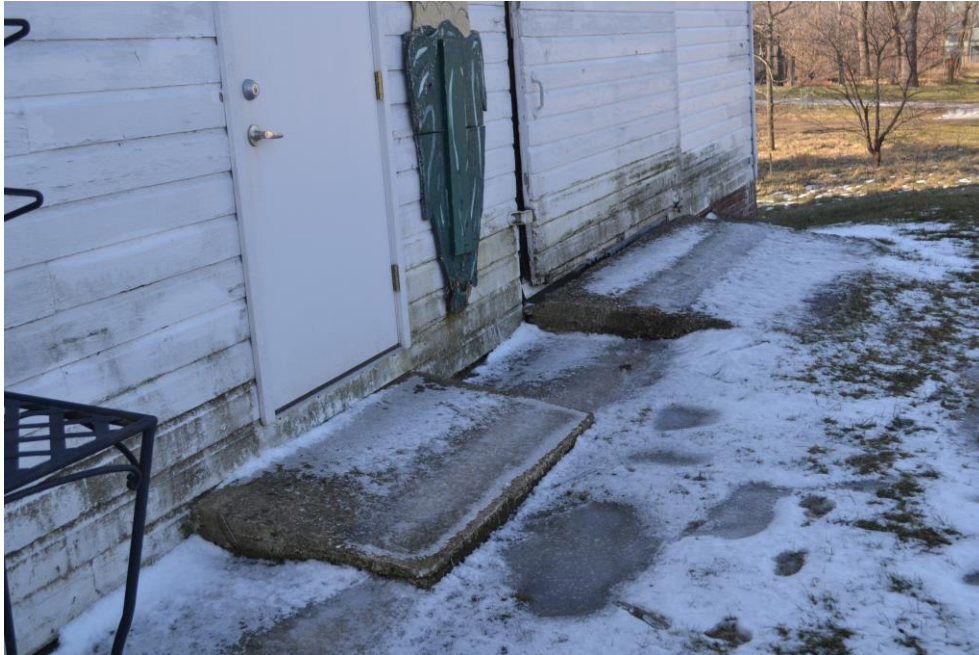
11. Rainwater is trapped along swale from concrete steps/pads into the building.

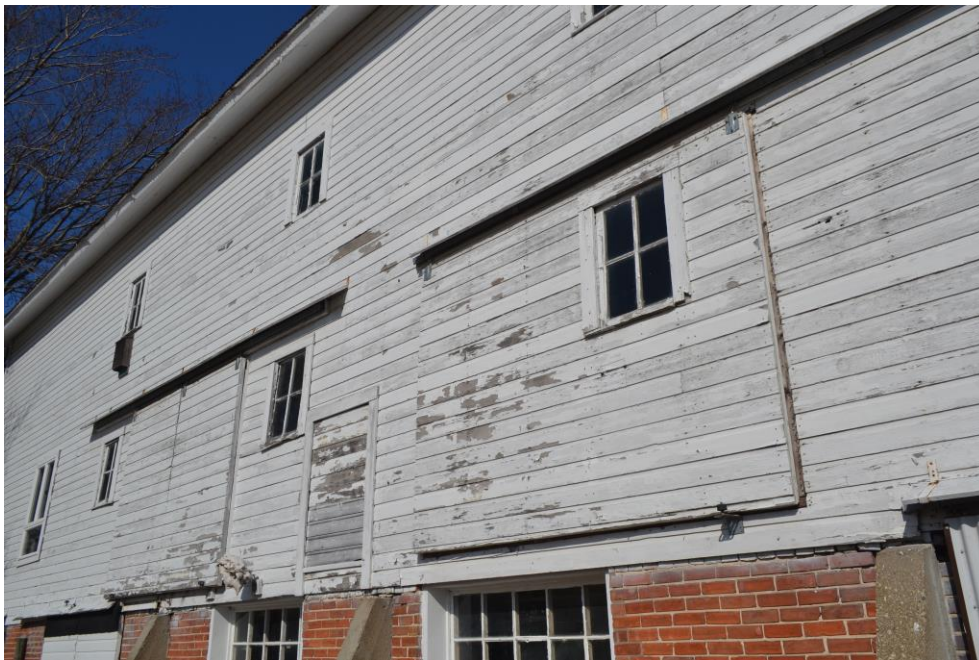
12. Aside from perimeter drainage issues, the exterior is in fairly good condition. Wood siding is in good condition with limited need for repair/replacement. Paint failure will require future scheduling of scrape/prime/paint.

The siding is generally in good condition. Minor deterioration was recorded in areas near grade, particularly on the north wall. Eventually, full-scale siding restoration should be undertaken through normal means of siding repair/replacement of deteriorated boards, scraping, priming and painting with two coats of paint. From a standpoint of long-term restoration, it is also recommended that the three new windows on the main level be replaced with historic profile windows. Other windows, which appear to be in good condition, should be preserved/restored during a full-scale building repainting.

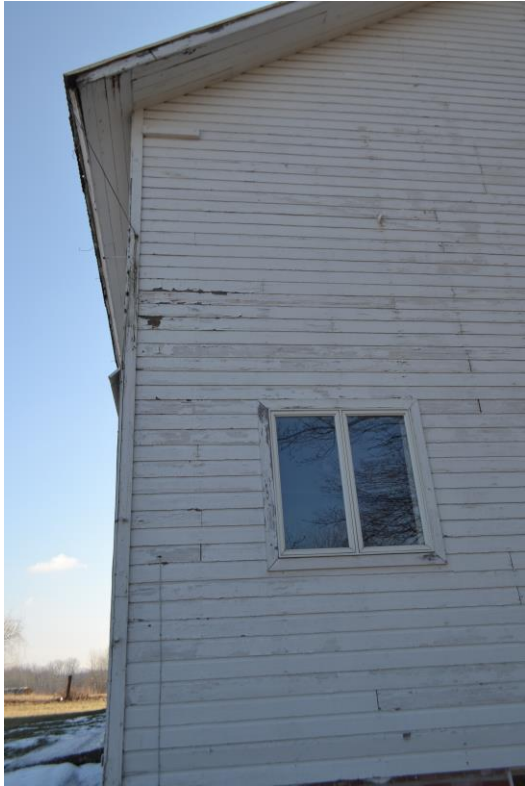
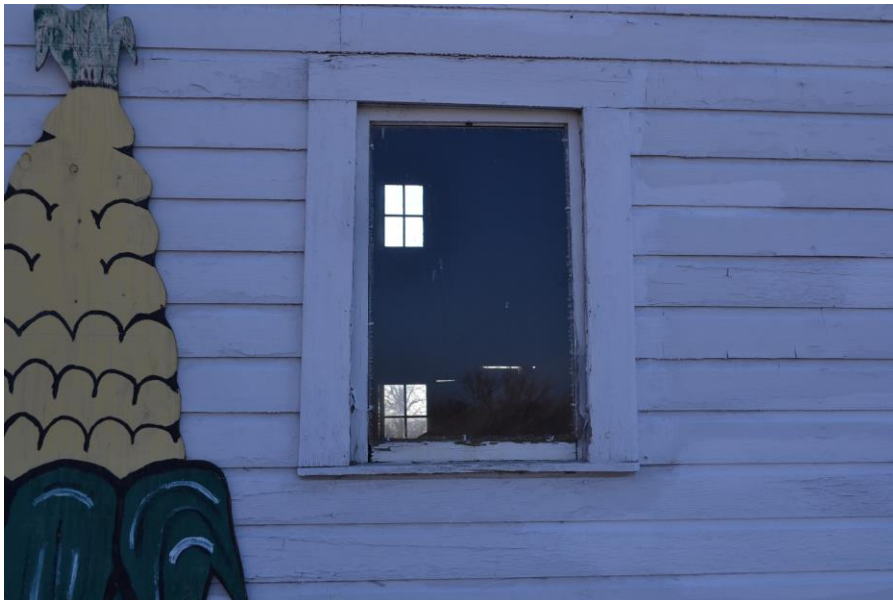
13-14. Three non-historic windows have been added or retrofitted into existing openings. In long-term restoration, it may be desirable to replace the new casements with divided, four-pane sashes (one on south façade and one on west façade). Similarly, one window in the north façade appears to be in an original opening location, but should be a divided, four-pane sash. This is likely an early replacement. A historic window is behind TFI's logo in the east gable; consideration should be made to expose and restore that window. Other windows are in good condition and easily preserved. West façade modern window above (13); replacement window north façade below (14).

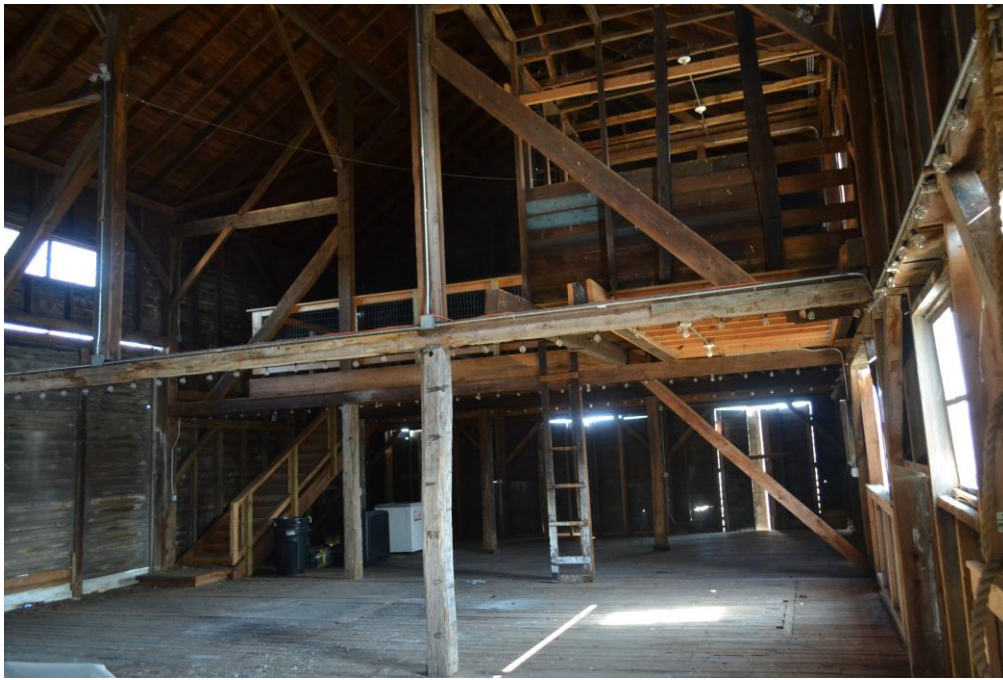
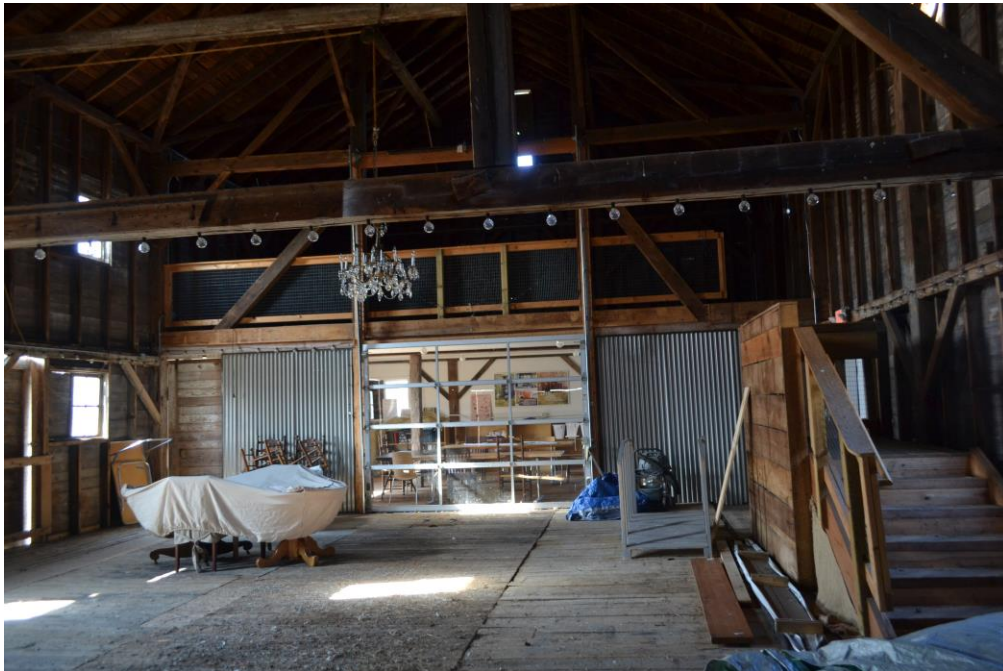
Late changes on the main level include the removal of a structural wood post in one of the bents. No movement from the removal was witnessed, but bents work in unison just like trusses, and removal of members can create other issues in tension or compression. It also appears loft areas were either added or expanded and railing composed of wire and modern wood were added. A broad staircase was added to the east loft while the west loft was cut off. A small, raised platform was added along the north wall. None of these greatly distract from the overall feeling or appearance of the space as a historic timber frame structure. The modern intrusion of a garage door is somewhat masked by corrugated metal and plank walls that enclose the area under the west loft. This enclosed space is better climate-controlled and sealed from birds, bats, etc. This space has finished interior walls and ceilings, exposed timber frame, and shelving. This space also includes two modern pairs of casement windows. A steel exterior door is in the north wall and is the primary access to the main level. Another exterior-related modern addition is the construction of a wood deck off the east side of the building. It has rustic-style, stick-built handrails.

15. Looking east (top) and 16 west (bottom). Missing structural post in bottom photograph.

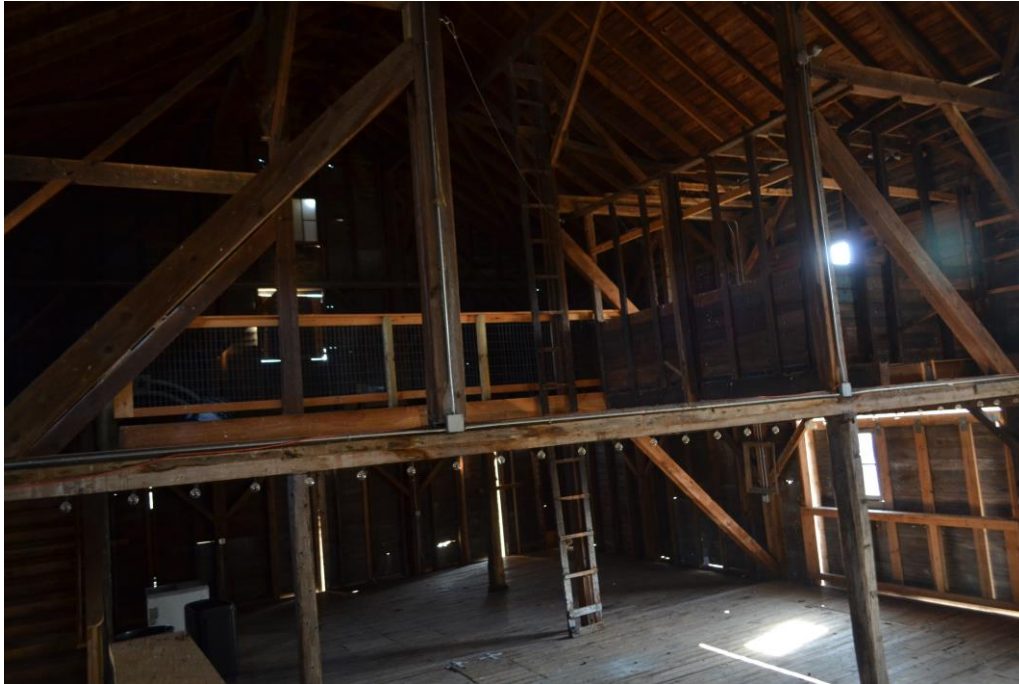
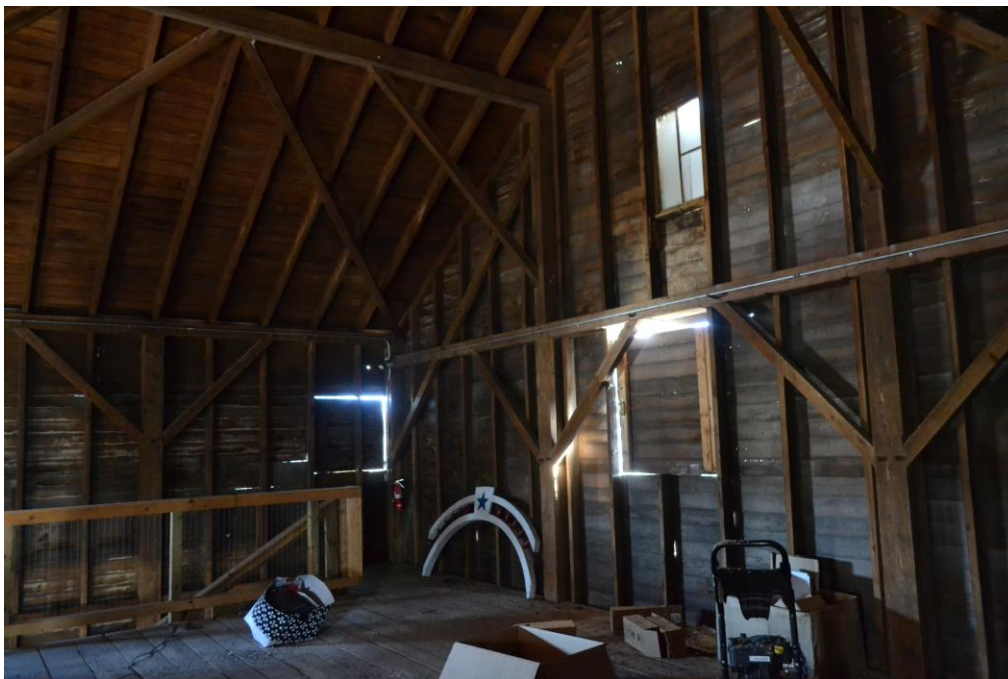
17. Looking east (top) and 18. northeast in east loft (bottom). Note missing structural post in top photo and existing, but covered gable window in bottom photo.

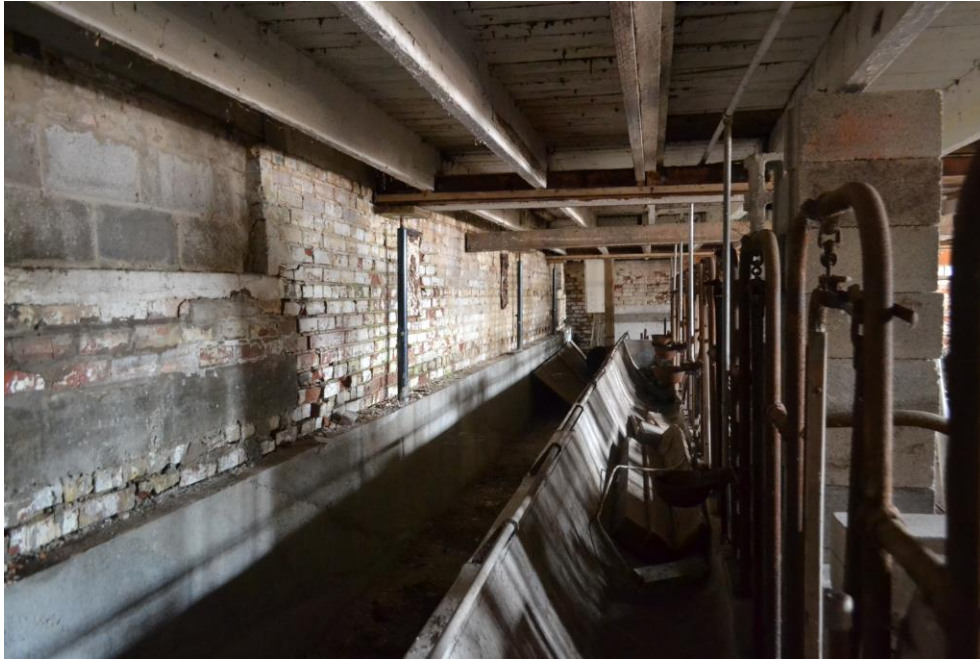
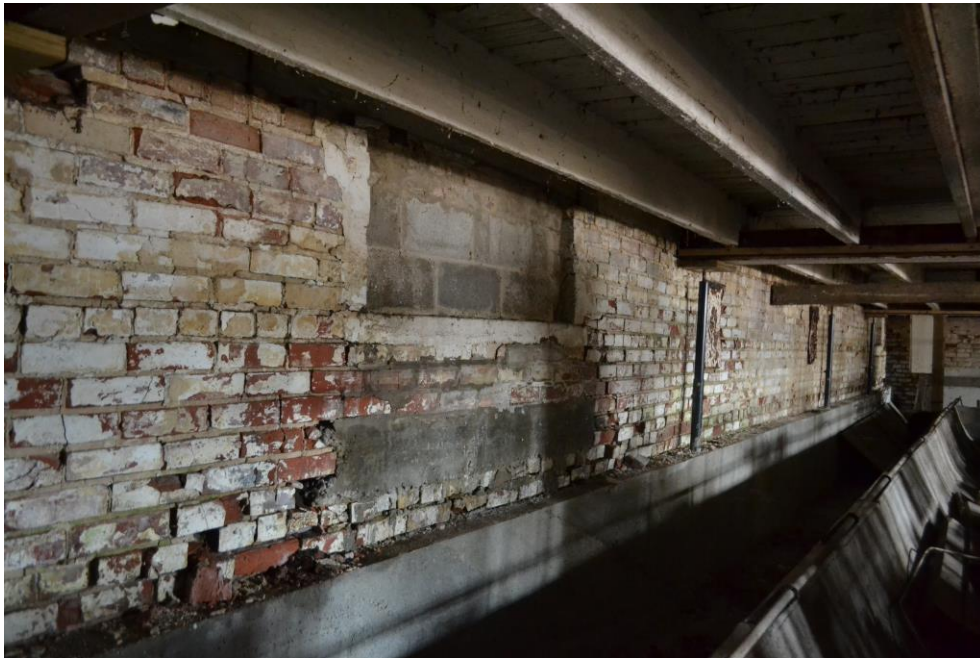
23-24. North basement wall shows signs of moisture settling down through the ground along the wall. Note that there were once windows in this wall, now blocked-in, which means that grade was likely raised a few feet at some time.

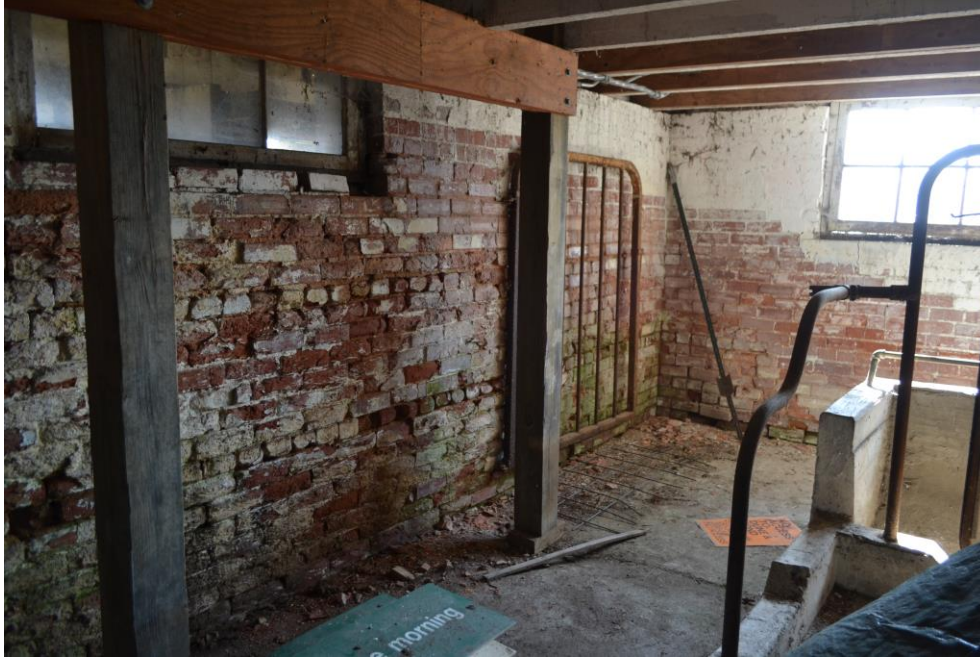
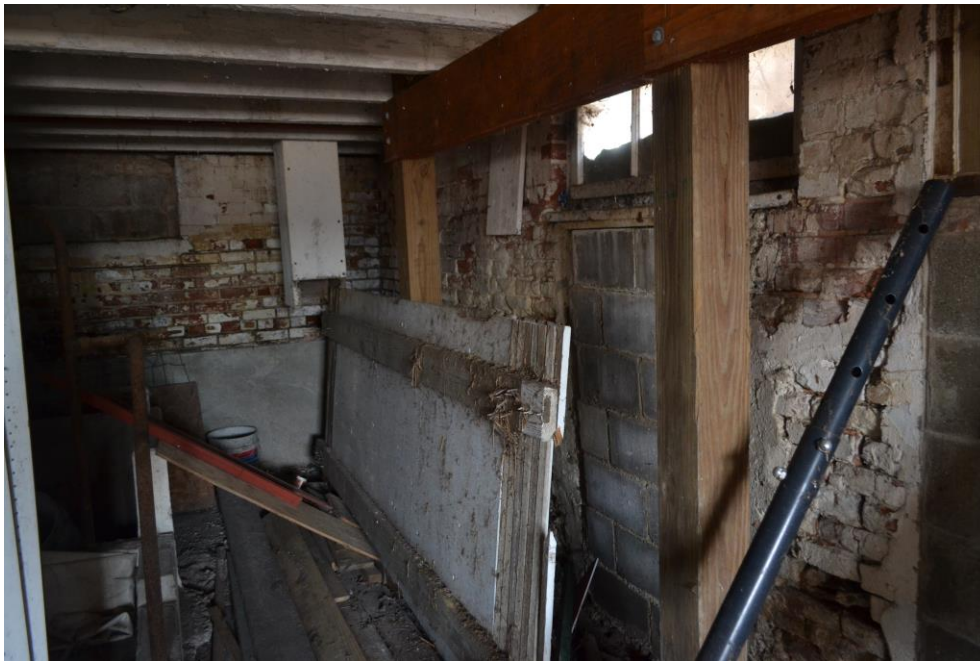
25-26. East basement wall showing masonry deterioration from moisture penetration. This area also appears to have been at least partially exposed with grade raised on the exterior. This end also includes new column and beam construction for reinforcement of main level floor.

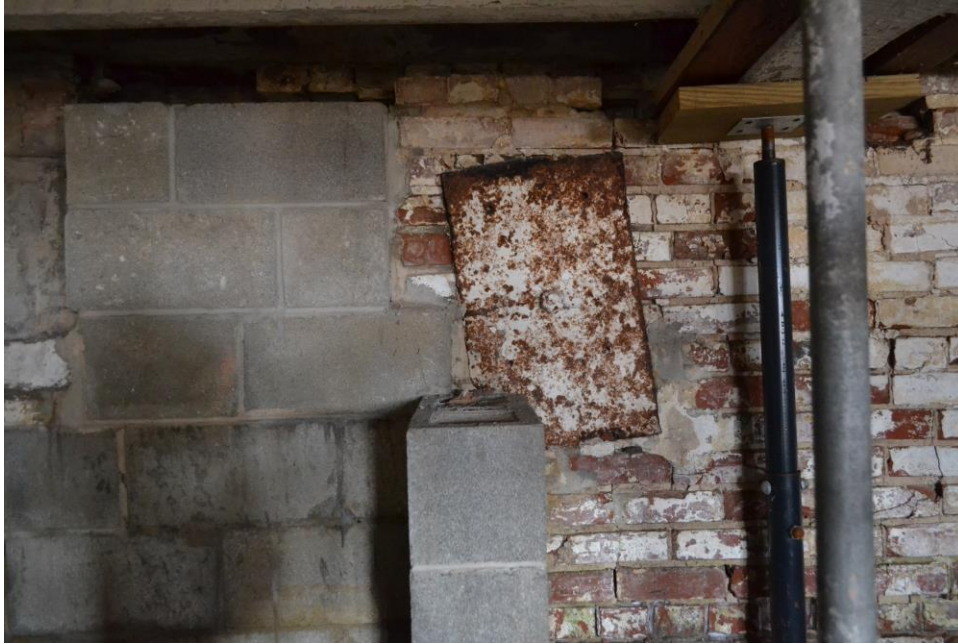
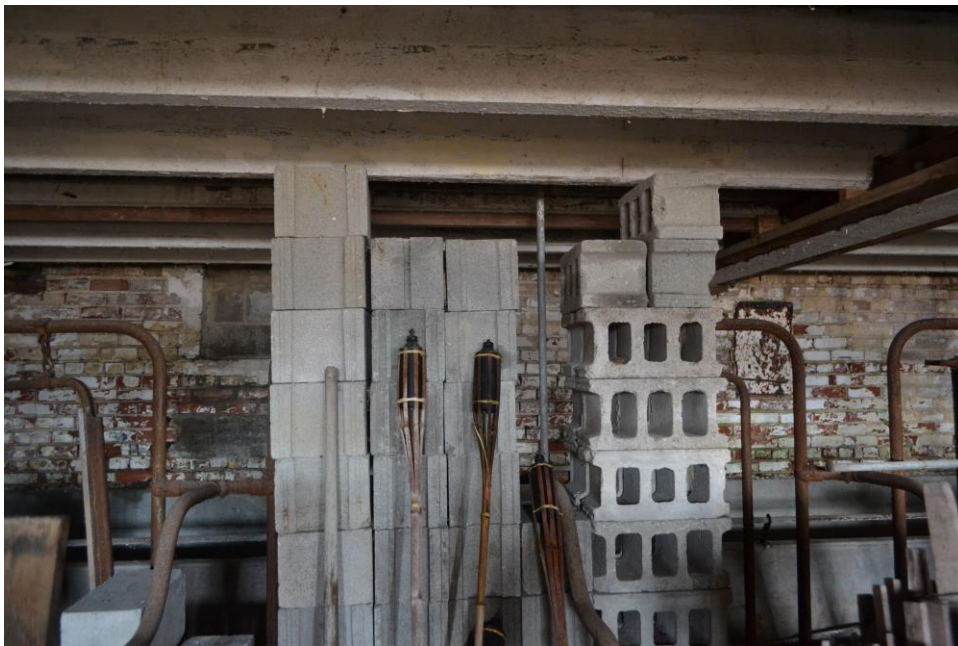
27-28. Some ad-hoc reinforcement of main level floor joists with concrete block and adjustable pipe columns. A traditional wood post and beam support could be exchanged with the ad-hoc materials.

As noted earlier, ad hoc adjustable pipe columns and concrete block have been installed in the basement to help support the main level floor. Similar engineering and design, like has been undertaken with wood posts and steel angles, should be completed and installed in these areas. Additionally, it is recommended that close monitoring of the area where a structural wood post column was removed on the main floor be undertaken. Ideally, columns would be reinstalled (rough sawn/hand hewn to match).

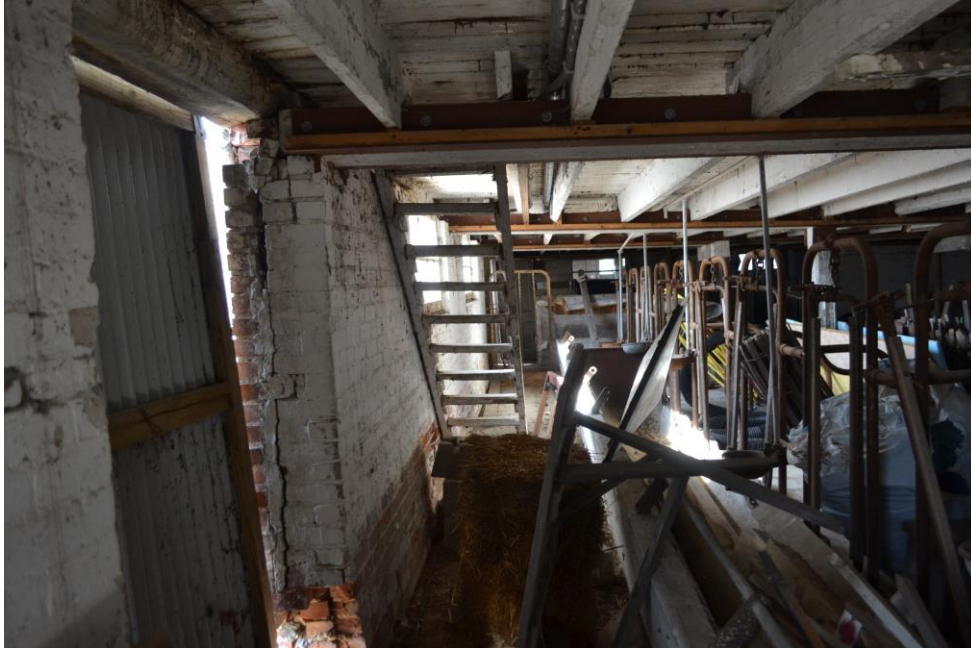
29. Looking west along south basement wall (above). Note separation of face brick on outside of wall and deterioration of masonry wall at base. 30. Passageway from milking floor to calving stall area (below).

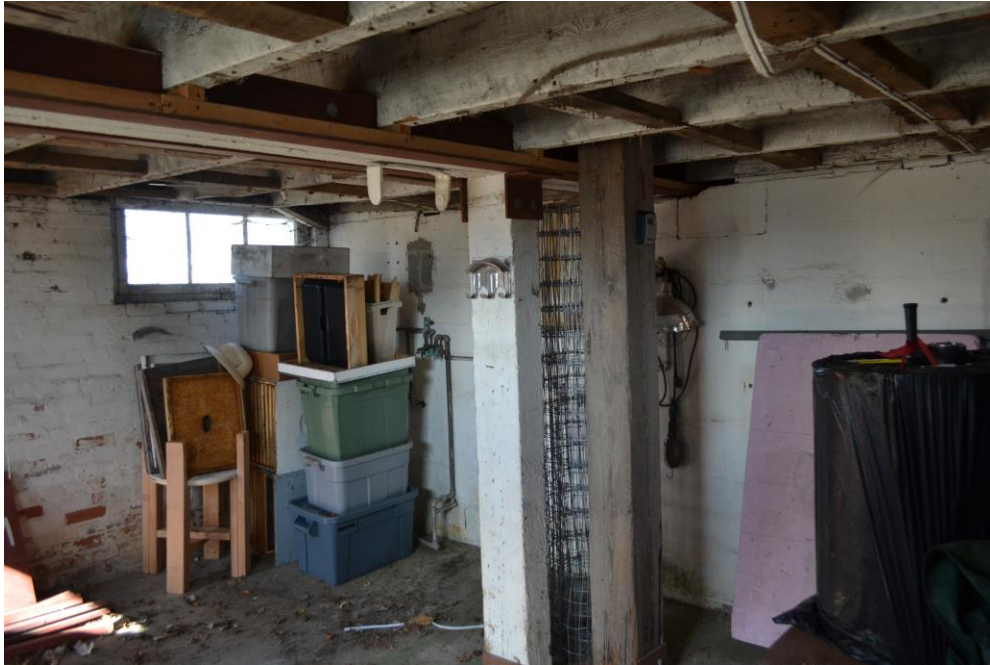
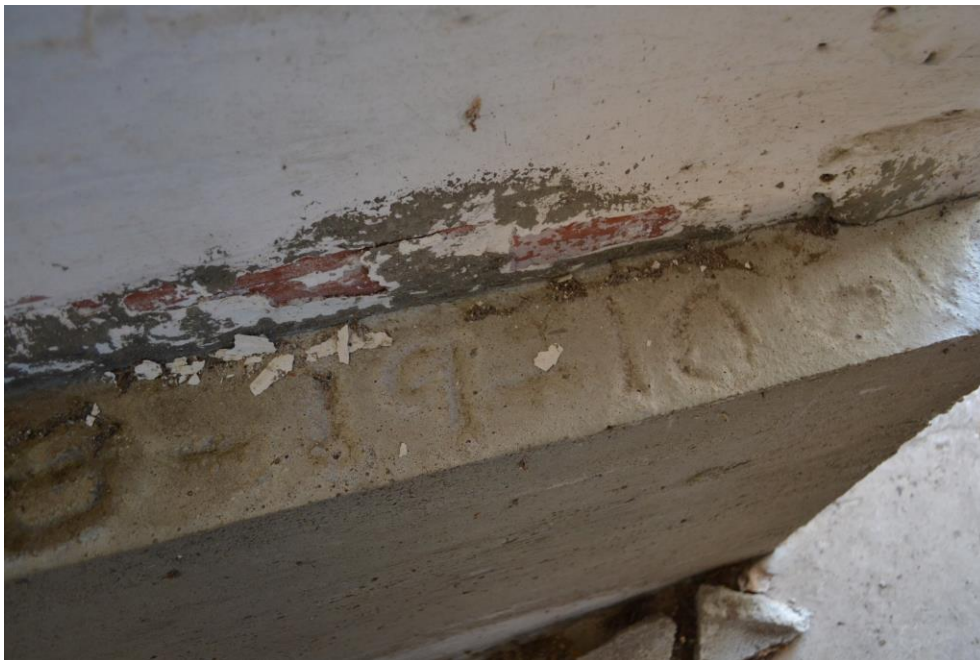
33-34. Dairy office in southwest corner features modest renovations and reinforcement, including masonry wall reinforcement along base of south basement masonry wall. Concrete buttresses were installed outside of the south wall sometime as an early reinforcement.

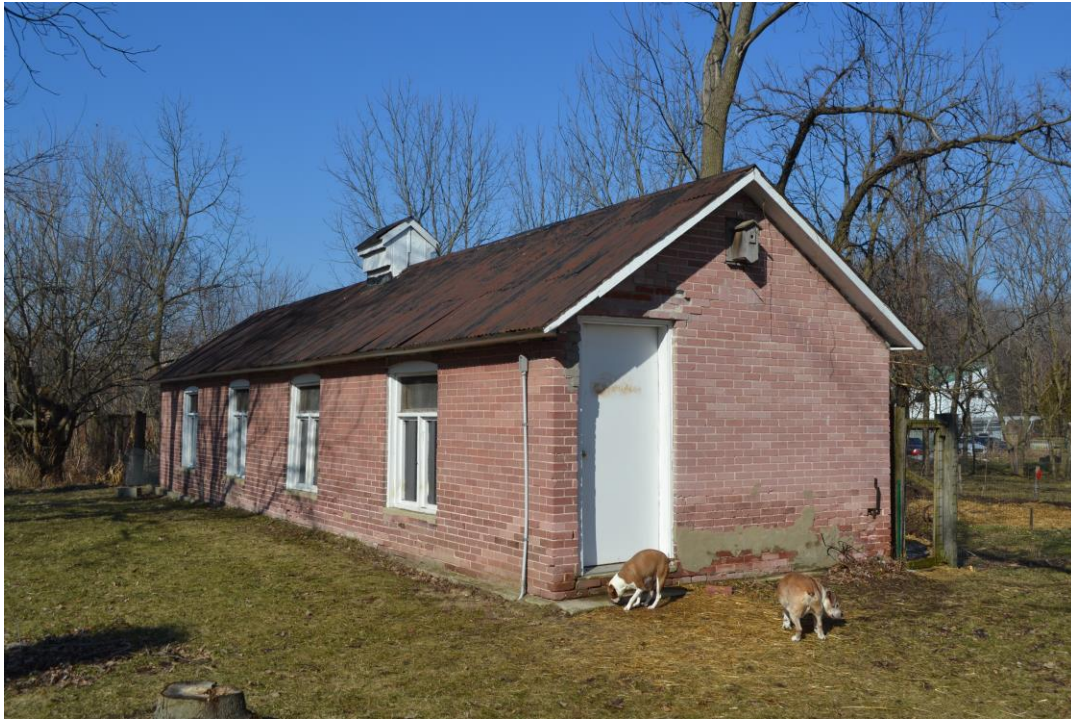
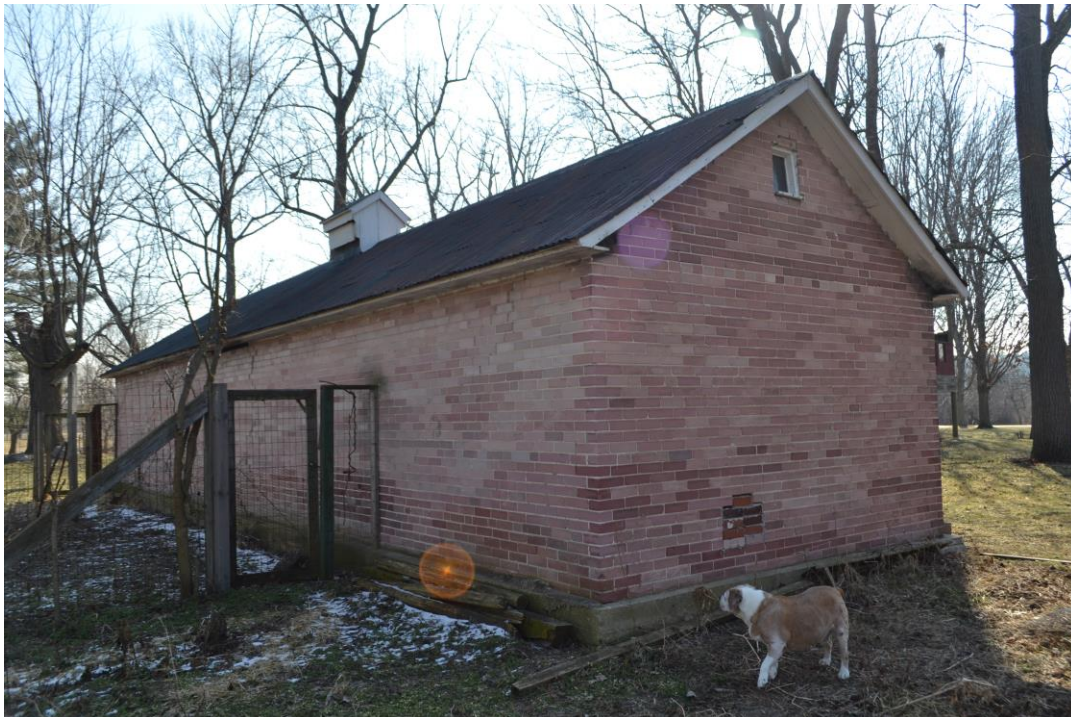
The chicken coop, considered a contributing building in the National Register nomination and also eligible to receive grant funding, is brick with a corrugated metal roof of the same age as the barn. The coop generally is in good condition, but obvious settlement cracks have occurred in the mortar joints, particularly on the north wall (36). The brick does not appear to be load-bearing masonry, but rather faced onto a wood frame structure. The settlement may be resulting from either deteriorated fasteners to the masonry, or a lack of fasteners. This brick may have been an added exterior finish sometime after original construction. Recommendation for this building would be to have a mason complete some investigative work, likely in conjunction with barn masonry restoration, and replace the metal roof at the same time the barn roof is replaced. The windows and ventilator appear to be historic, if not original. The metal door, however, is a modern replacement (35). For restoration purposes, TFI should consider replacing the metal door with a wood door of vertical boards.

35-36. Chicken Coop. Above note inadequate mortar parging on front wall and settlement over modern metal entry door. Below note obvious settlement in mortar joints on back (north) wall.
